Comprehensive Lead Based Paint Hazard Risk Assessment for the USFS Sheridan Work Center 201 Mill Street, Sheridan, MT 59749

June 13th, 2016

**Reference: Comprehensive Lead Based Paint Hazard Risk Assessment Report
USFS Sheridan Work Center
201 Mill St.
Sheridan, MT 59749**

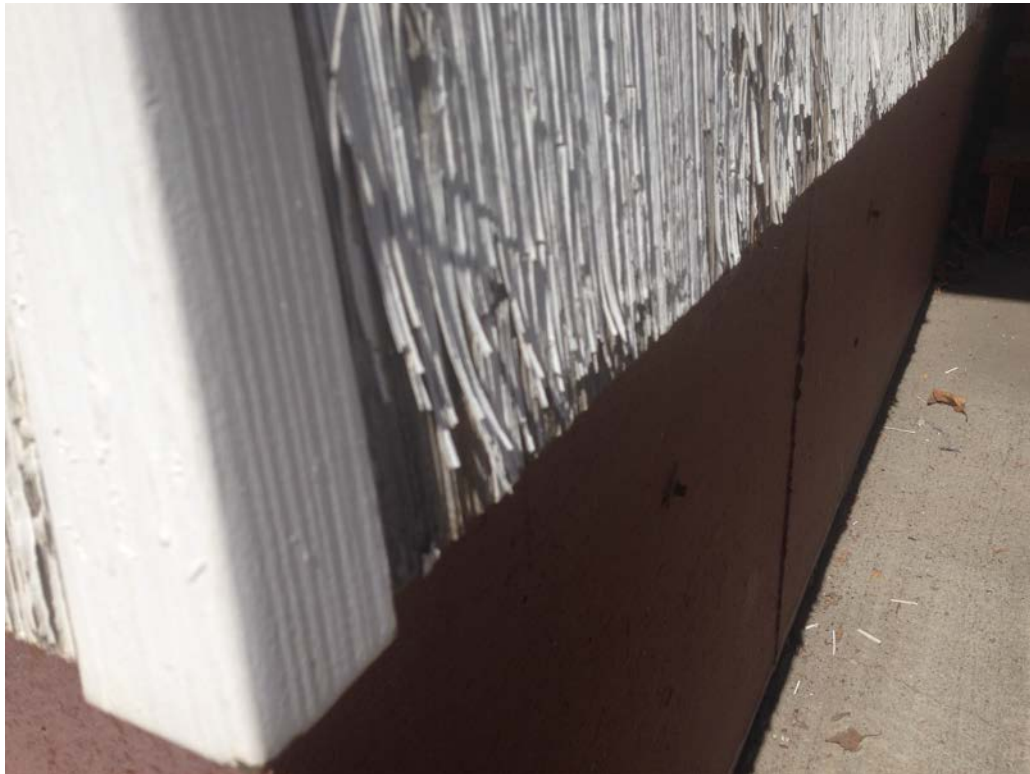
Coating Condition- Mostly Intact, Flaky, and Peeling portions

XRF Results: 3.04 mg/cm^2

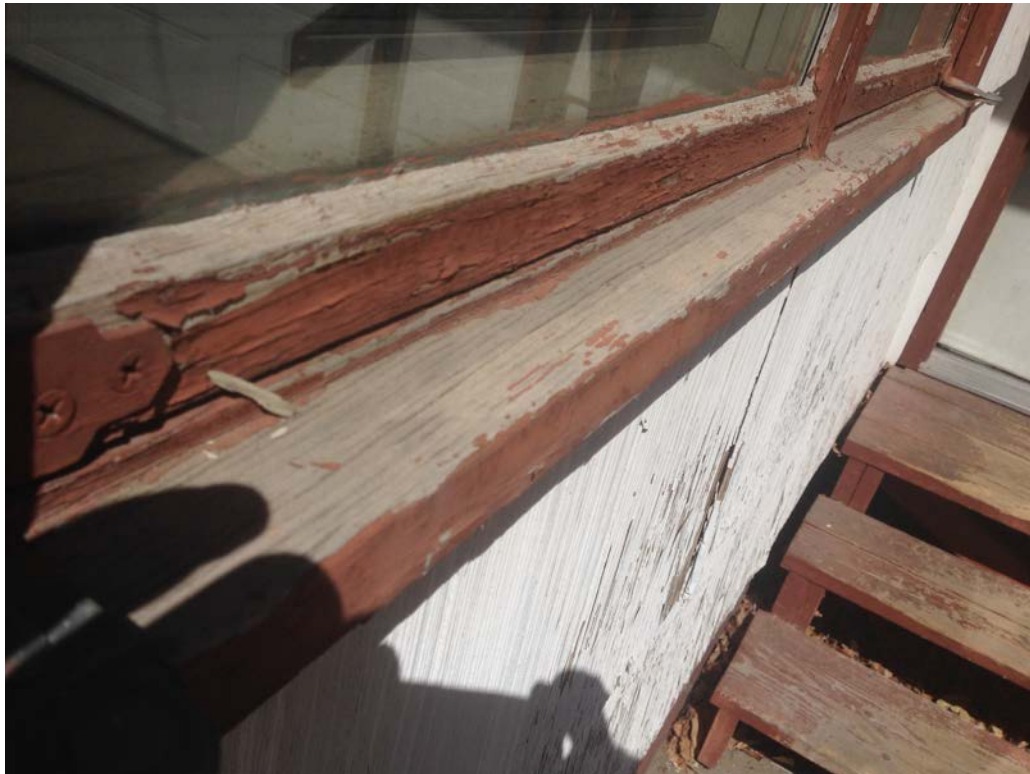
Maroon Coating on Exterior Window Trim

Coating Condition: Mostly Intact, flaky and peeling portions

XRF Result: 1.75 mg/cm^2

- 1) Hazard A: Exterior Window/Door Trim
- 2) Hazard B: Exterior Siding
- 3) Hazard C: Exterior Roof Trusses

The aforementioned components may be stabilized by removing the loose paint and other material from the surface of the substrate (e.g. we scraping, HEPA vacuuming) and applying new protective coating of paint, or by replacement (if feasible).

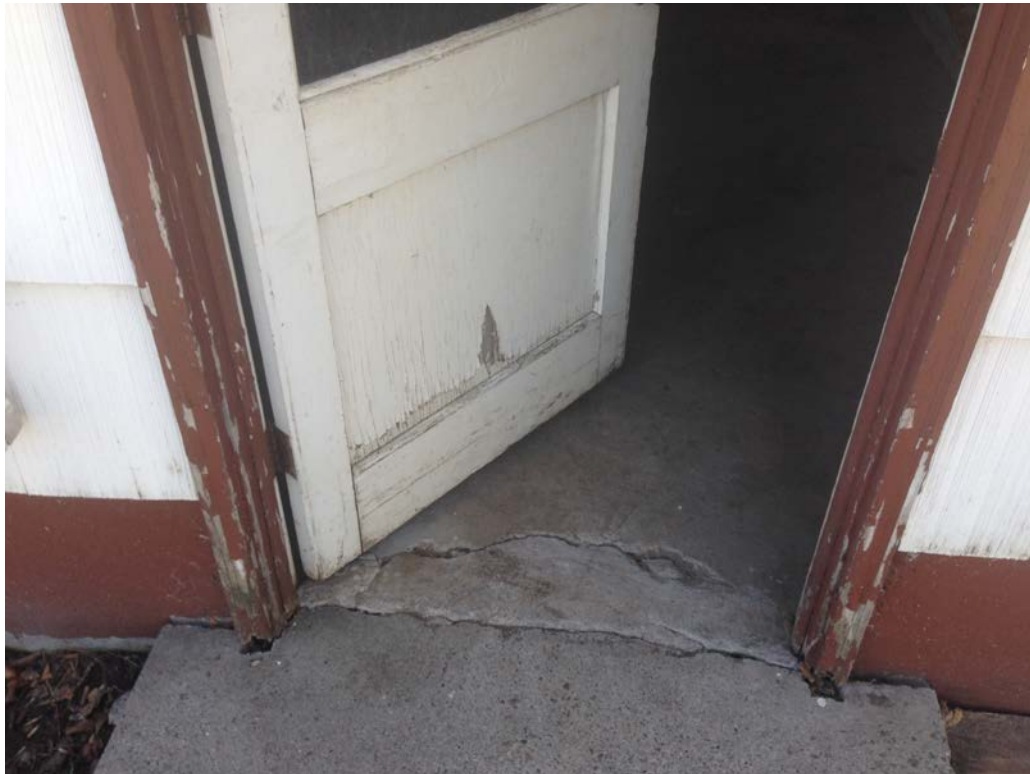
Maroon coating on Exterior Door Trim

Coating Condition: Mostly Intact, Flaky and peeling portions

XRF Result: 1.75 mg/cm^2

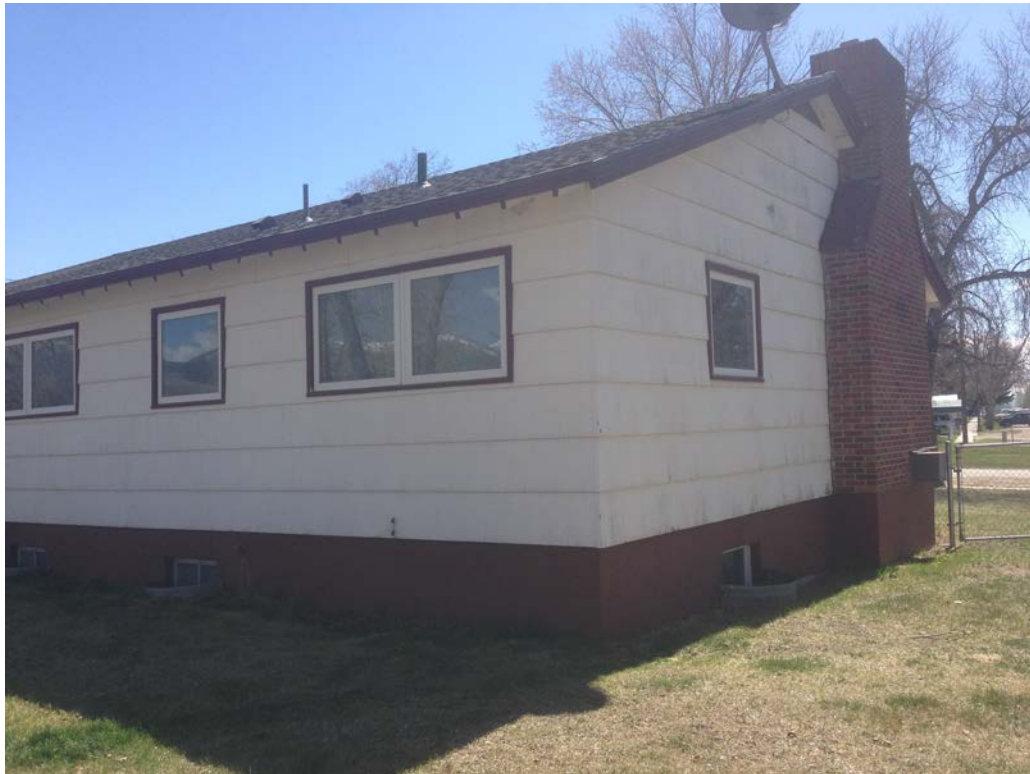
Maroon coating on Exterior Roof Trim

Coating Condition: Mostly Intact, Flaky and peeling portions

XRF Result: 1.75 mg/cm^2

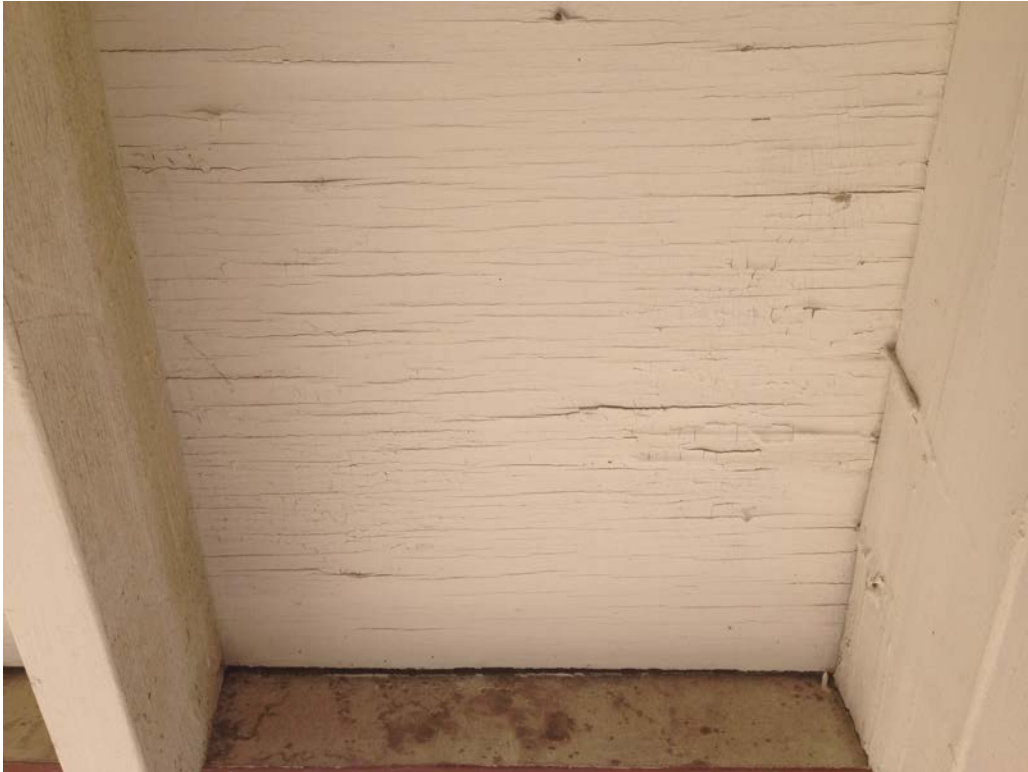
White Coating on Roof Wood Panels

Coating Condition: Mostly Intact, Flaky and Peeling Portions

XRF Result: 1.97 mg/cm^2

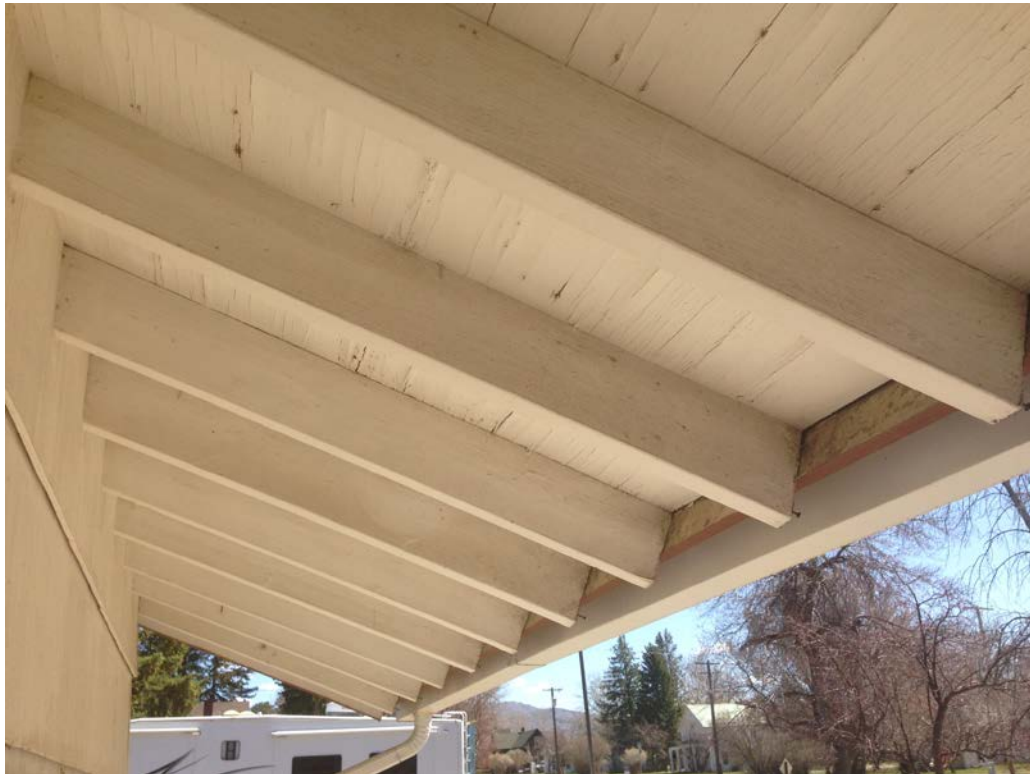
White Coating on Wood Trusses

Coating Condition: Mostly Intact, Flaky and Peeling Portions

XRF Result: 1.33 mg/cm^2
